Recycling's day in the sun

Ariz. thoroughfare brought back to life using innovative hot in-place recycling technique

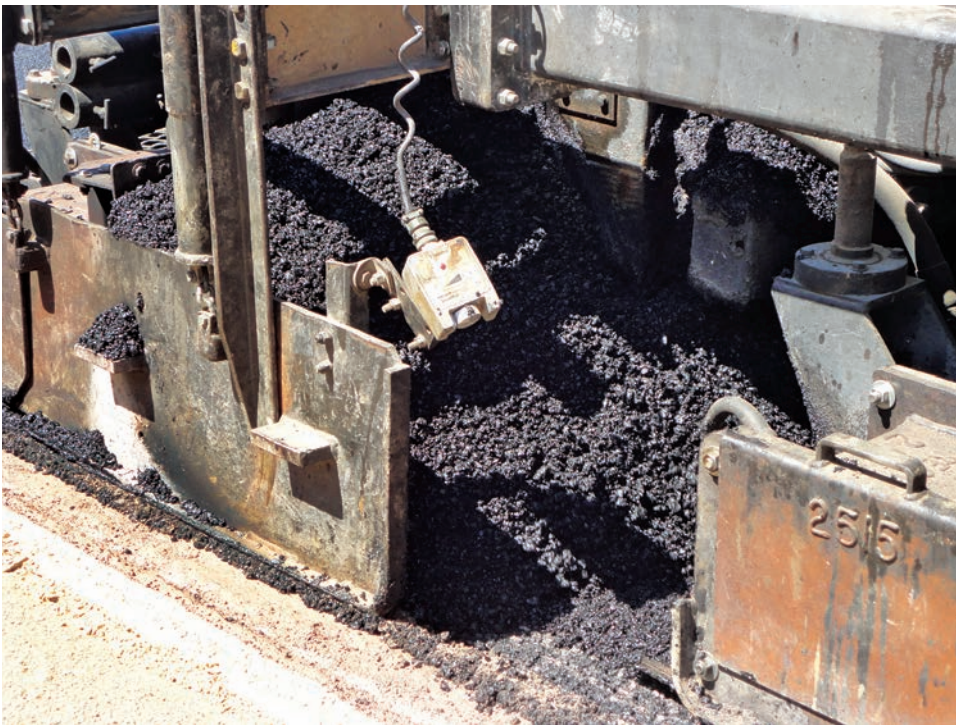
The paver can be augmented to any width needed via a series of pre-made, 1-ft extensions for the heating hood, scarifying teeth and the recycling auger. This adaptability allowed Cutler to set a new Arizona record with one pass of 18 ft.

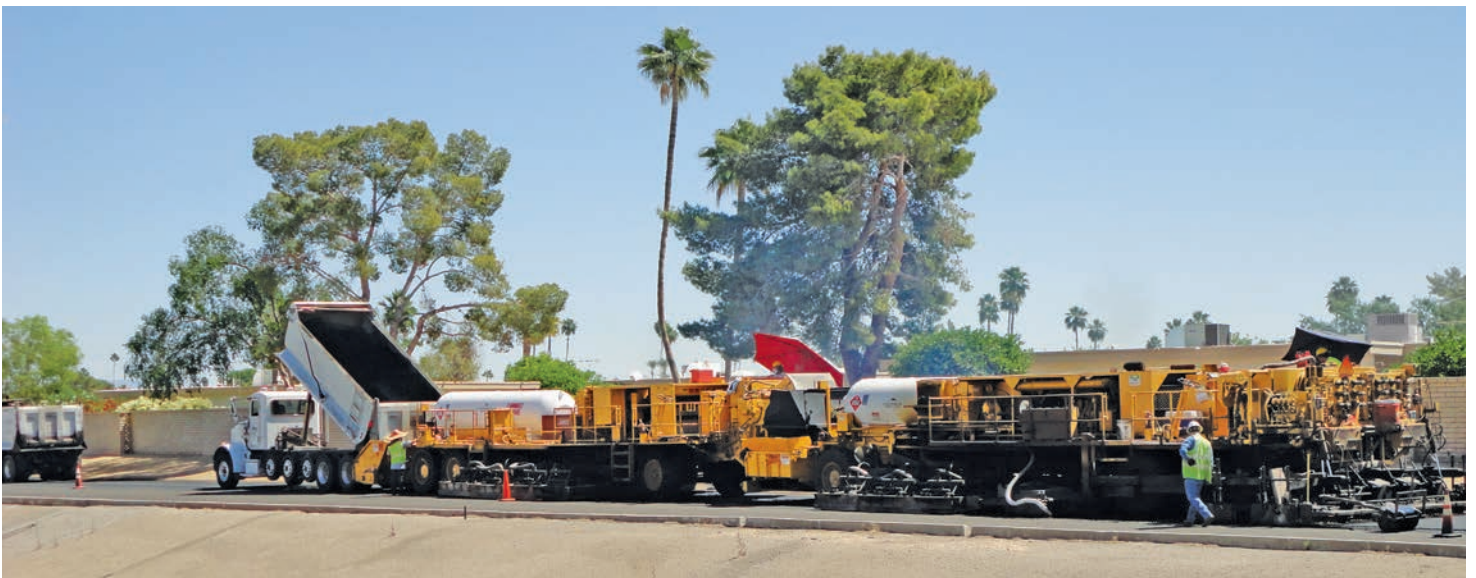
Cutler brought in its own paver. Going one lane at a time, the machine heated, scarified and recycled the top layer, refreshing it with new asphalt emulsion. While the recycled layer is still hot (at least 200°F), an additional inch of fresh material is placed on top.

From that point, Cutler brought in its own paver. Going one lane at a time, the machine heated, scarified and recycled the top layer, refreshing it with new asphalt emulsion. While the recycled layer is still hot (at least 200°F), an

additional inch of fresh material is placed on top, improving the durability of the rejuvenated roadway. With the addition of the extra inch on top, the final grade of the new surface is usually an inch higher than the original pavement. Once a lane is completed, the paver backs up and moves onto the next lane.
