# Recycling's day in the sun

Ariz. thoroughfare brought back to life using innovative hot in-place recycling technique

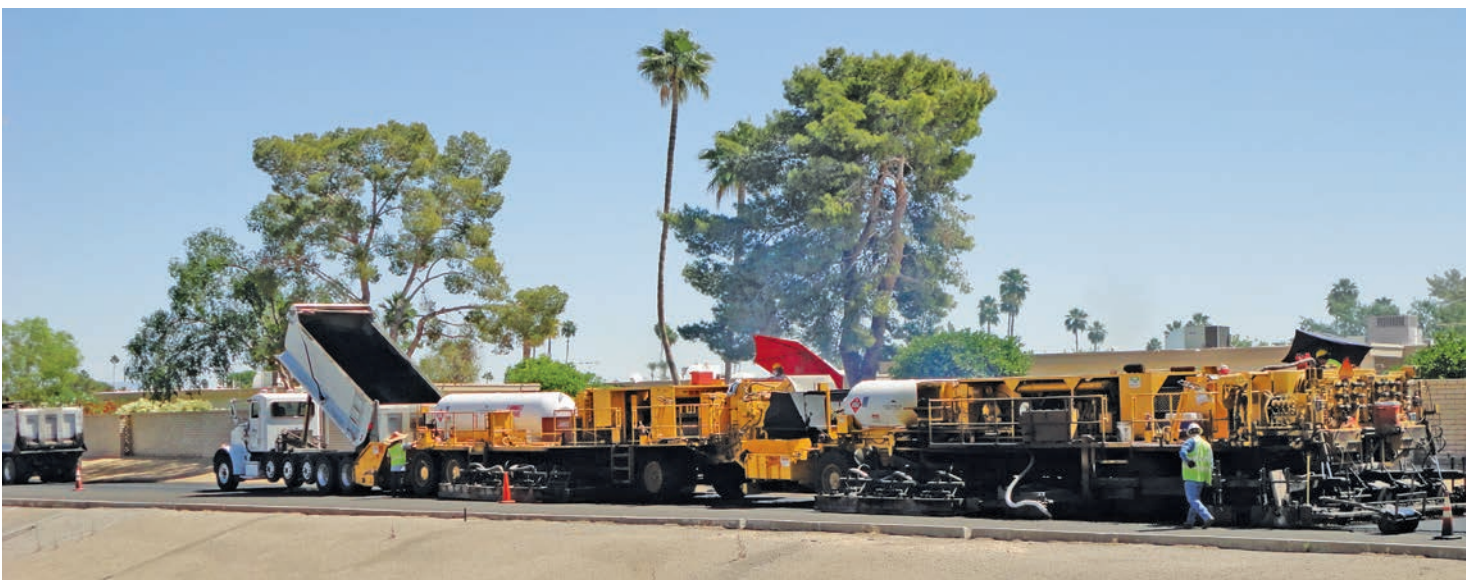
Cutler brought in its own paver. Going one lane at a time, the machine heated, scarified and recycled the top layer, refreshing it with new asphalt emulsion. While the recycled layer is still hot (at least 200°F), an additional inch of fresh material is placed on top.

From that point, Cutler brought in its own paver. Going one lane at a time, the machine heated, scarified and recycled the top layer, refreshing it with new asphalt emulsion. While the recycled layer is still hot (at least 200°F), an

additional inch of fresh material is placed on top, improving the durability of the rejuvenated roadway. With the addition of the extra inch on top, the final grade of the new surface is usually an inch higher than the original pavement. Once a lane is completed, the paver backs up and moves onto the next lane.
