CUTLER COURIER

PEACH OF A PROJECT

Peach Harvest Uninterrupted as New Technology Helps Colorado Hot In-Place Recycling Job Win Smoothness Honors

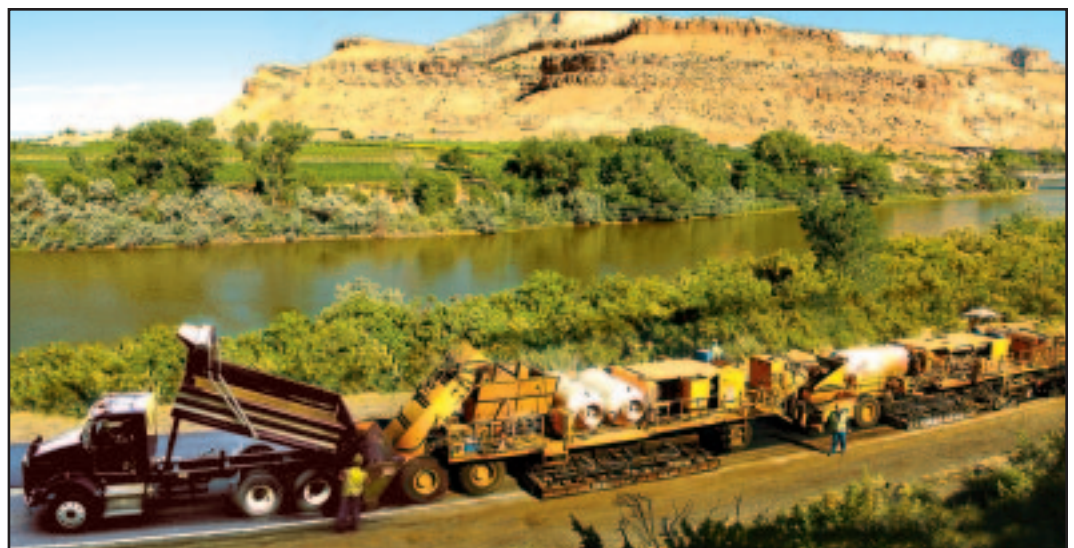
Cutler's new preheater-conveying-vehicle (PCV).

But the crew had a weapon in reserve, Cutler’s new preheater-conveying-vehicle (PCV). The self-propelled PCV preheats the aged asphalt pavement in advance of the main recycler, while receiving virgin HMA for the surface course. Much like a material transfer vehicle, the PCV isolates the main repaver from HMA delivery trucks, eliminating the ubiquitous “bumps” between paver and truck which cause mat discontinuities, thus assuring a smooth surface.

The new PCV does several chores: Because it must operate closer to the repaver than the conventional preheater, there is less cool-down between the preheater and repaver; it eliminates the traffic-disrupting backing of the truck up to the paver; and quells thermal segregation of virgin mix. Its 260-square-foot heating hood generates 12.5 million Btus of heat.

“We developed this unit to function as a material transfer vehicle which could store 15 to 20 tons of hot mix asphalt ahead of the paver, but with a heating hood up front,” said John Miles, Cutler vice president of operations. “The key to getting smoothness is to never stop the paver. The PCV feeds the hot mix from the trucks to the paver so we can maintain a constant, uniform speed without stopping and starting. And in our process, we need to preheat the pavement ahead of the repaver. The new PCV combines heat with HMA storage ahead of the main machine.”

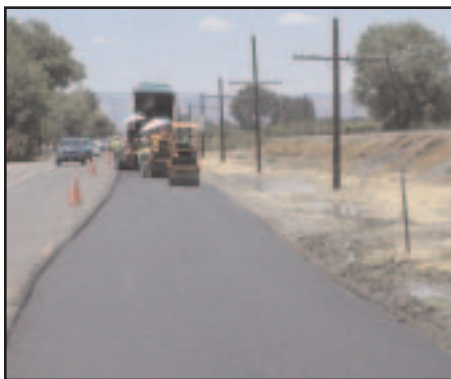
One-pass repaving keeps work zones compact, traffic flow smooth.

The one-pass repaving also kept the work zone compact, Eller said. “On a small job like this, if we have multiple operations, the job gets spread out, and you get work for six miles, instead of work in one half-mile section. So we thought in the long run this might be better, because we would be in and out quicker.”

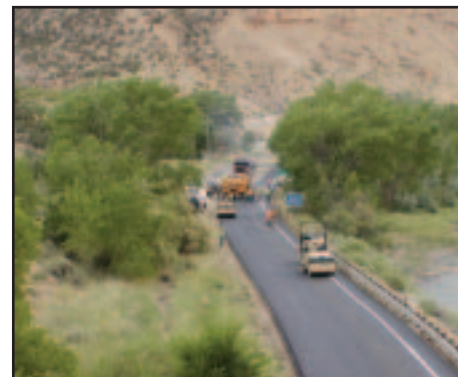
Elimination of longitudinal joint produces smooth process.

But Cutler's unique process eliminates the longitudinal joint, because repaving also reheats the edge of adjacent paved lanes, resulting in a more durable, higher-density seam between the driving lanes. In essence, the longitudinal joint is eliminated. "Longitudinal joint density was tested, along with final profile of the entire project," said Colorado DOT's Ray. "The state measures density in the longitudinal joints, but with this project they got the highest longitudinal joint density we've experienced, because the process reheats the existing joint, and matches them up. We were getting joint densities of 92, 93, up to 96 percent in some areas. Really, there is not a joint to speak of, and that gives us a smooth process. We did not find any must-grinds."

"A key to smoothness here on the U.S. 6 project is that this longitudinal joint was reheated, cut out and replaced by the repaver," Shea said. "It really made a difference. Cutler's people knew what they were doing and took care of all the details. Density and leveling were taken care of. The reason this project won three awards was that the repaving process levels prior to final paving, and rolling happens all at once at the end. It is an interesting process that produces a fine product."
